# BLIP Operations 2-21-12

# BLIP repair

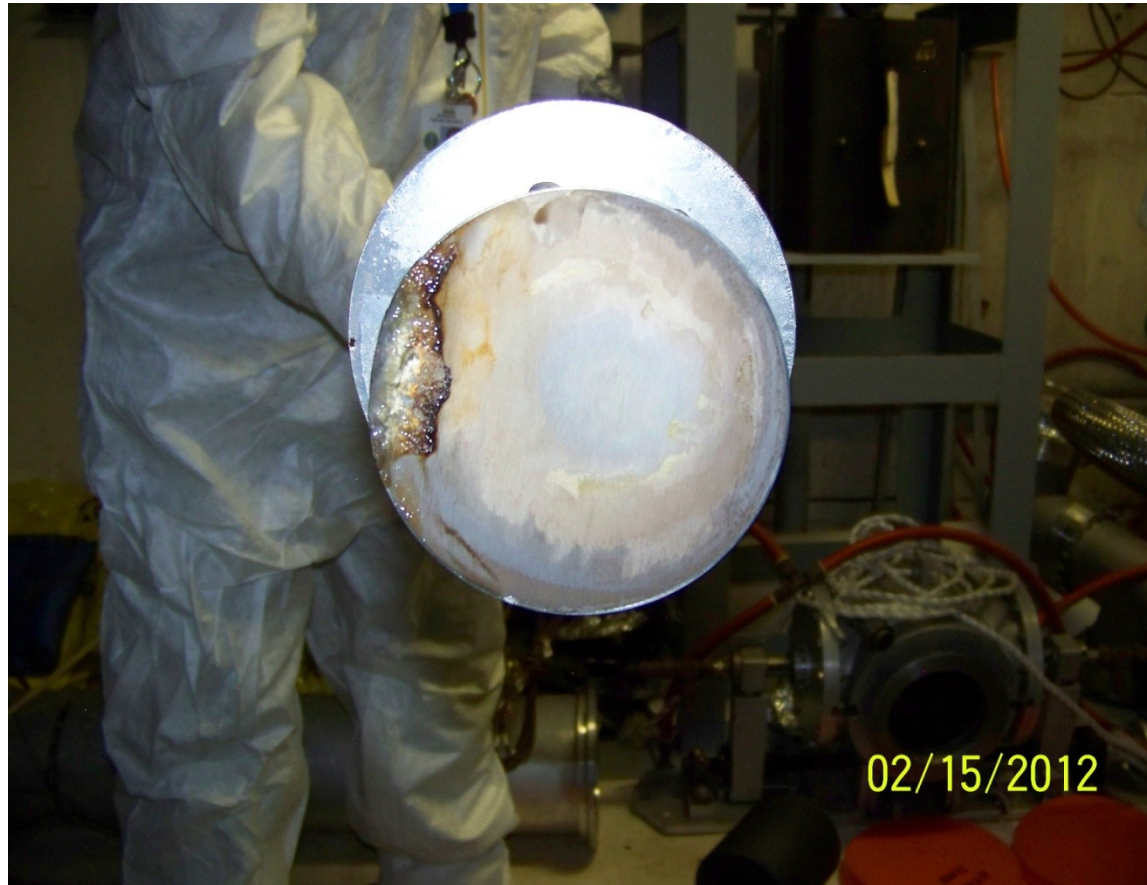
- Status – running at 117.1 MeV @75μA
  - Shutdown Tuesday-Saturday morning. Weekly operations for 70.5 hours
- Issues
  - BLIP shutdown after vacuum leak was detected on Tuesday morning. Entry on Wednesday morning confirmed the leak and cause. The AlBeMet beam window was badly corroded. It was removed.

# AlBeMet beam window (4" diameter)

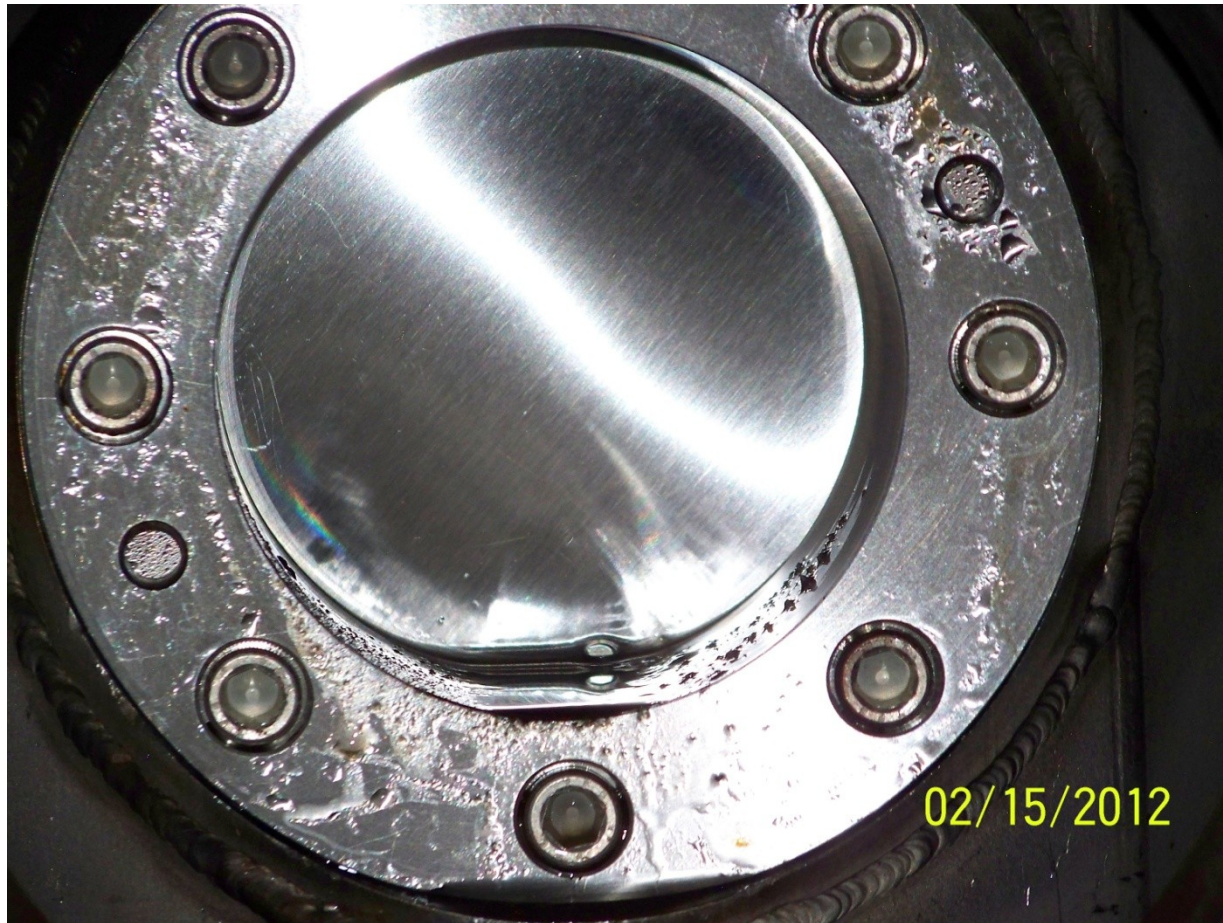
BLIP water window (measured 4950R/h at  
10cm)

- Radiation dose measured 4950 R/h at 10cm!
- Failure occurred after 5.5 weeks of beam compared to 7 years for previous window of same design.
- water all over implies leaked water vaporized and then condensed on all cooler surfaces.
- no obvious crack, hole or burn mark visible implies possible failure of seal or cracked weld not visible in photograph.
- Sample of water taken and gamma spectroscopy performed to compare isotope content with BLIP cooling water samples. The spectra did not match.
- Water window replaced Friday and cooling system refilled.
- Saturday morning after final inspection for leaks, vacuum sections were replaced and pumped down.
- Beam restored at 11:23AM at reduced beam current ( $\sim 58\mu\text{A}$ ).
- Failed window will be transferred to main hot cell in bldg. 801 for closer inspection and possible determination of cause of failure.
